# Sycamore Park Interpretive Sites

■ Site Marker Base photograph dated 2003

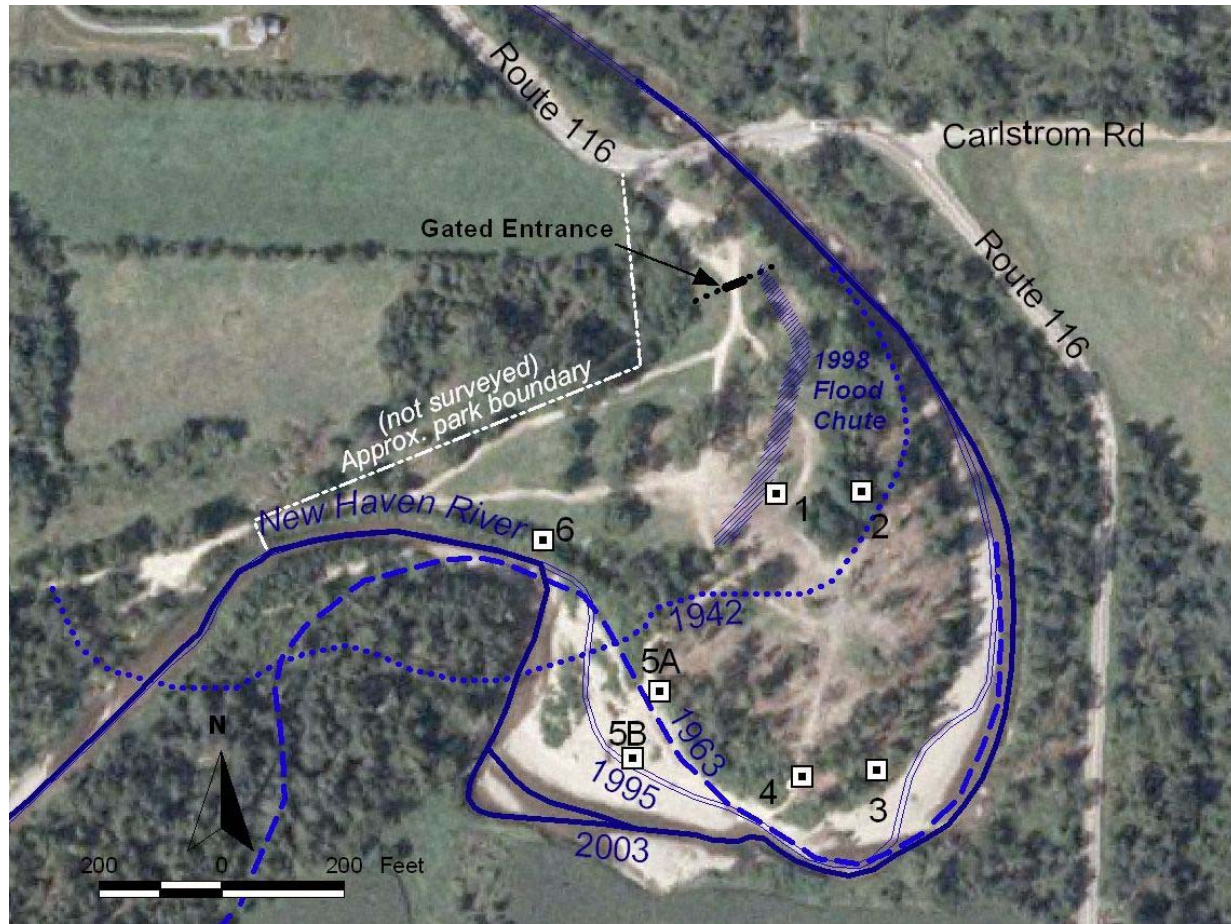
Site 1 overlooks a 500-foot long depression in the floodplain scoured by the New Haven River during the flood of June 1998 (**flood chute**). One of the ten homes in Palmer's Court was located on this spot prior to the flood. Compare this location on the 2003 photograph above with the same position on the 1995 photograph on the reverse side of this brochure.
