Downtown Bristol Traffic Study

Final Report Completed:
February 10, 2003

Prepared for the

REGIONAL PLANNING COMMISSION

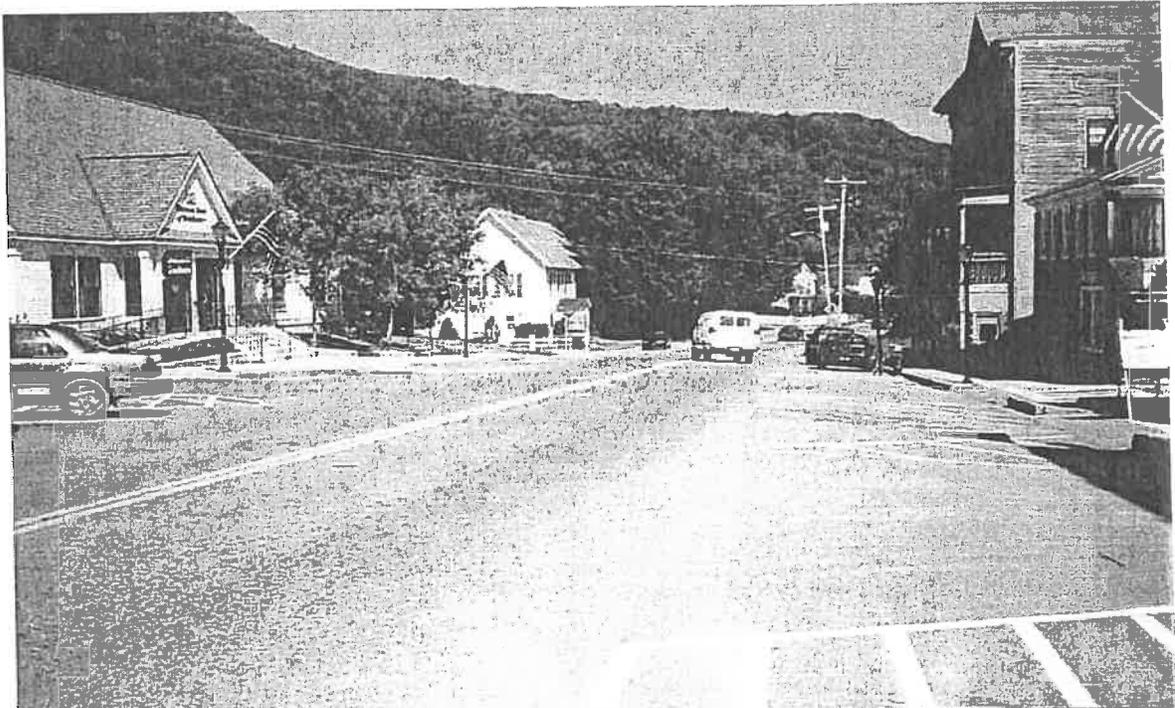
Image 1 : Downtown Streetscape / Lighting

Existing roadway lighting consists of luminaires on the utility poles along VT 17/116 through the downtown area. There are also historic style pedestal pole lights along Main Street as can be seen in Image 1.

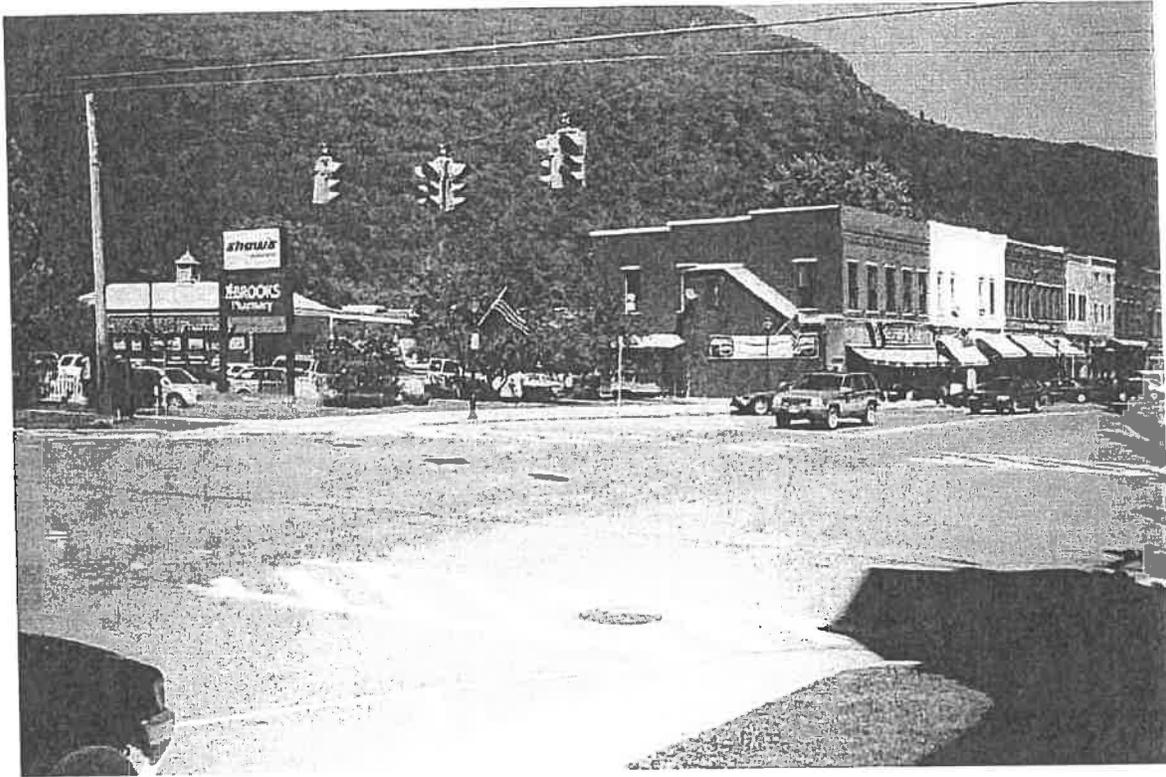
Image 3 : North / South / West / Main Street Traffic Signal

The primary intersection traffic control along West / Main / East Street is a traffic signal which exists at the North / South / Main Street intersection as shown in Image 3. The signal is operating on a fixed timing plan with a 65 second cycle and two phases (one for Main Street and one for North / South Street). There are no vehicle detector loops currently operating at this intersection. The controller for this signal is a Traconix HMP-40 controller which is obsolete and difficult to find replacement parts for. A separate rotary timer sets the signal into flashing operation from 11 p.m. to 6 a.m.

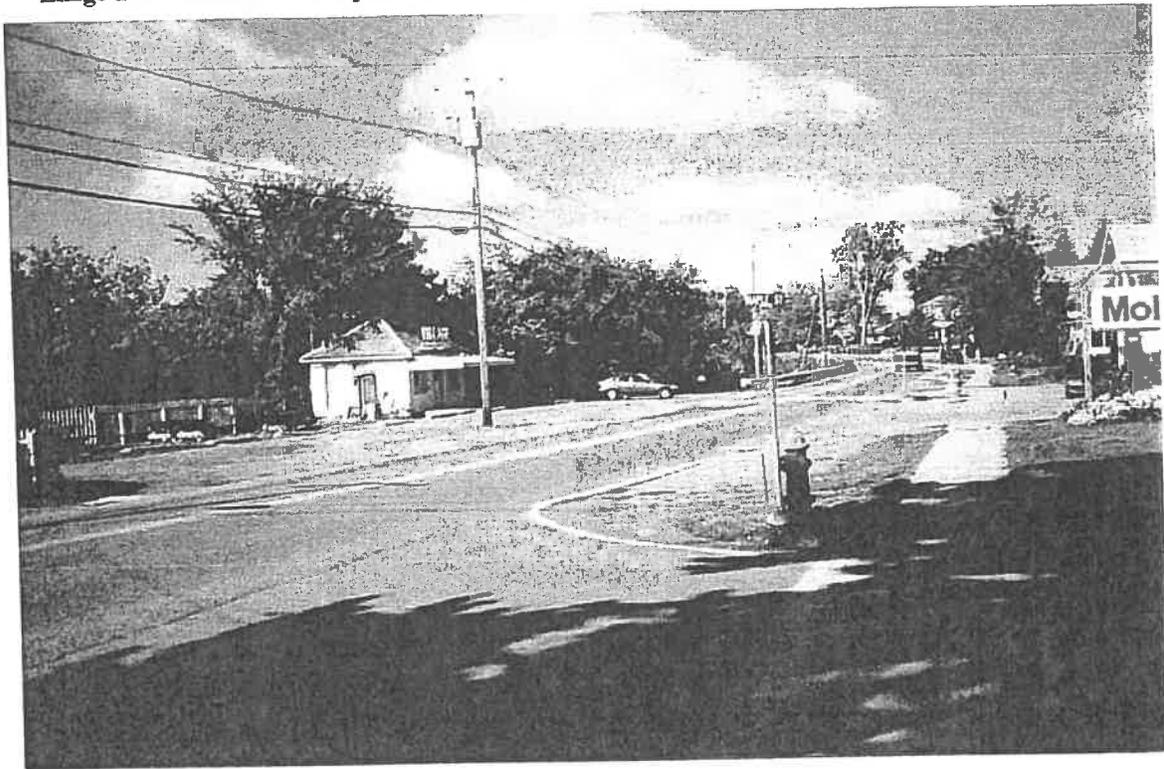
Image 10 : West Street / Maple Street Intersection (Bristol Village Mobil / Village Creemee Stand)

Bristol Police accident records indicate that the area at the West Street / Maple Street intersection is a high accident area. An examination of the existing conditions in this area indicates that the wide gravel shoulders along West Street and Maple Street are being used for parking by Bristol Village Mobil and Village Creemee Stand customers. There is a "no parking" sign on the north side of West Street for this area which is not always being obeyed.

Bristol Village Mobil has two relatively wide, uncontrolled access points which may be contributing to the high incidence of accidents at this location. This is also an area of high pedestrian / bicycle activity in the summer months. Vehicles seldom yield to pedestrians at the mid-block crosswalk between the Bristol Village Mobil and the Village Creemee Stand. This is particularly true of the higher speed vehicles approaching from the west who are not anticipating a crosswalk in this location. Image 10 shows existing conditions in this location.

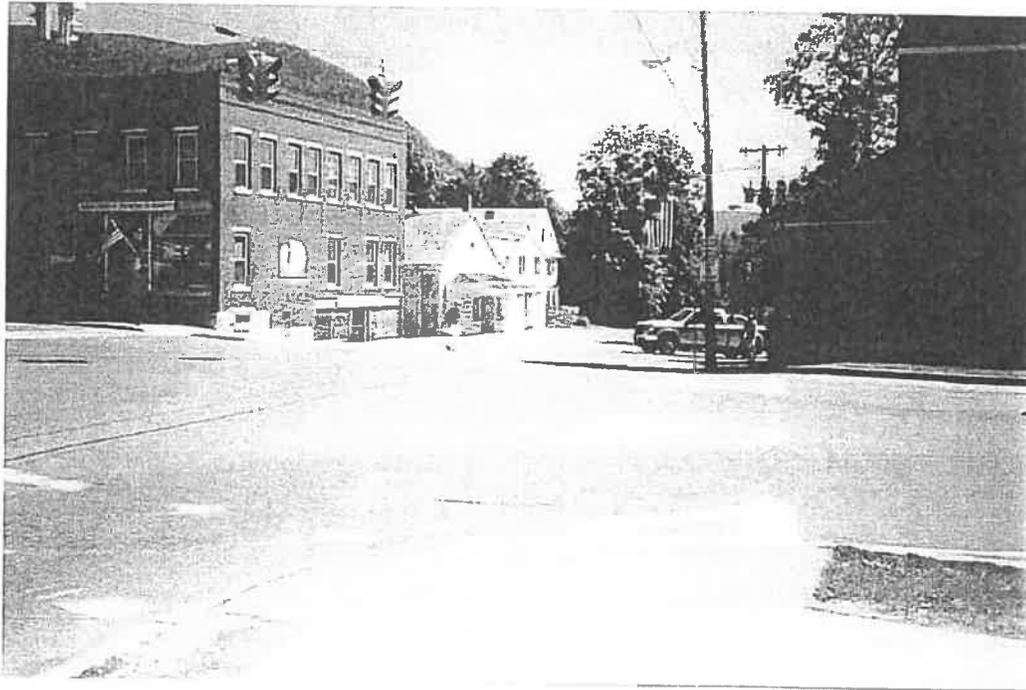
Image 11 : Vehicle Backed into Diagonal Parking on South Street

parking on the west side of South Street. There is also room between the first two telephone poles on South Street to shift the sidewalk closer to the town office building and provide a buffer strip between the parking spaces and the travel lanes on South Street for the first 100 feet.
